Underwater Hull Inspection (final)

Type	Motorboat/Motoryacht
Name	Seven Seas
Model	Leader 46
Year of construction	2016
Boat type	Motoryacht
Hull no.	L4748567-84
WIN	HR4748585
Engine	2x Volvo Penta D4-50A
Flag	Croatia
Callsign	HR4858
MMSI	HR4959696

Date: February 19, 2025

Location: Marina Kornati

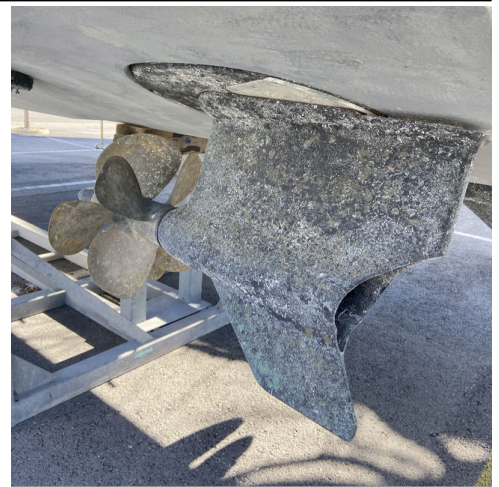
#1 **Location:** **Portside prop**

Observation: It's in good condition

Result: ■ Ok

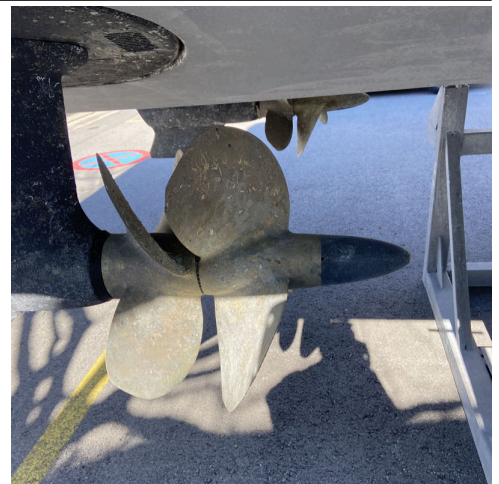
#2 **Location:** **Starboard prop**

Observation: Is in good condition

Result: ■ Ok

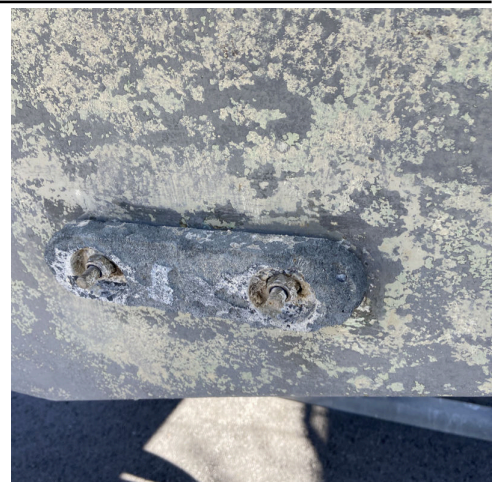
#3 **Location:** **Anode**

Both propulsion drives were inspected and found to be in good condition. The propeller units appeared in reasonable shape, with no visible damage or significant wear. However, all sacrificial anodes must be replaced to ensure continued corrosion protection.

Observation: Not in a good condition

Result: ■ Serious flaw

Advice: Needs to be replaced

Cost: Anode 2x

150 €

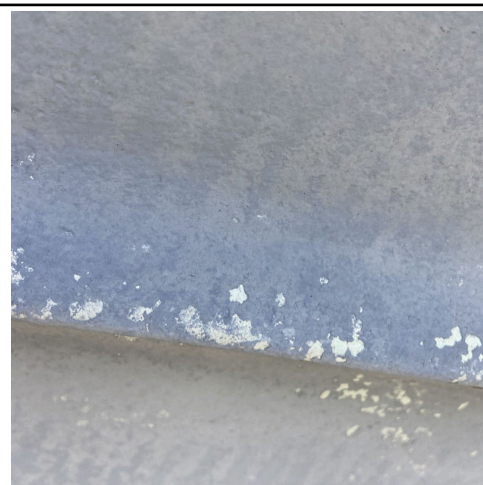
On February 19, 2025, an underwater hull inspection was conducted on the Leader 46 motor yacht Seven Seas while it was on land at Marina Kornati. The general condition of the hull was found to be satisfactory, with no structural issues detected. However, the antifouling coating was no longer present and requires reapplication.

ID	Details	
#4	Location:	Hull anti fouling
	Observation:	No active anti fouling
	Advice:	When continuously in water needs to be completely renewed
	Result:	 Flaw
	Cost:	Anti fouling for 46 1580 €
	Date:	19/02/2025 11:19 AM
