for.Inspectors (DEMO)

Inspection report (final)

Boat data

Introduction

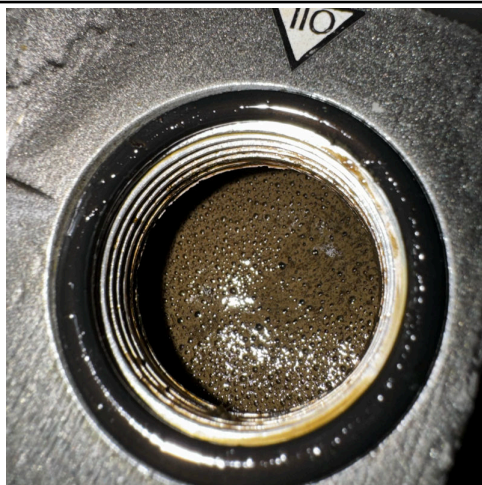
#1 **Location:** **Port engine room**

Observation: Water in gearbox oil
Advice: Needs to be checked (root cause) and repaired.
Result: ■ Serious flaw
Date: 29/12/2024 04:08 PM

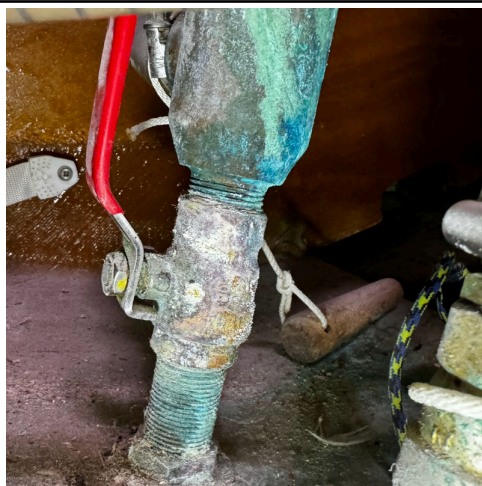
#2 **Location:** **Starboard hull / main bilge compartment**

Observation: Heavy corrosion
Advice: Needs to be replaced.
Result: ■ Serious flaw
Date: 29/12/2024 04:08 PM

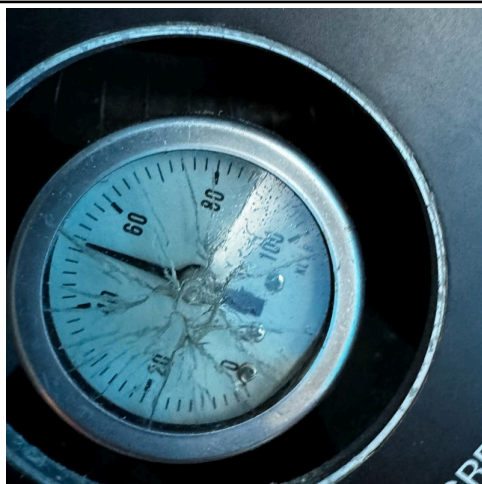
#3 **Location:** **Starboard engine room**

Observation: Broken glass on manometer of the water maker
Advice: Needs to be replaced
Result: ■ Serious flaw
Date: 29/12/2024 04:10 PM

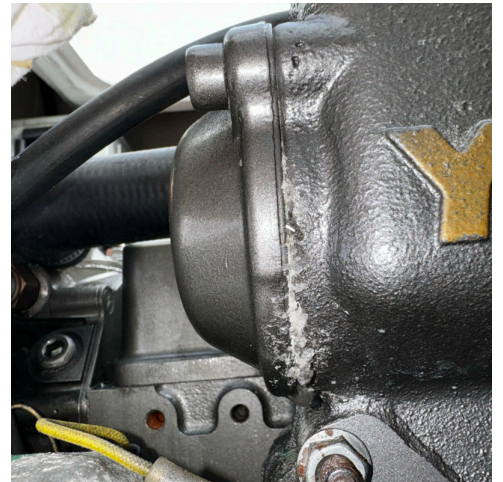
#4 **Location:** **Port engine room**

Observation: Leaking cooler

Result: ■ Serious flaw

Advice: Warranty: needs to be fixed by shipyard under warranty

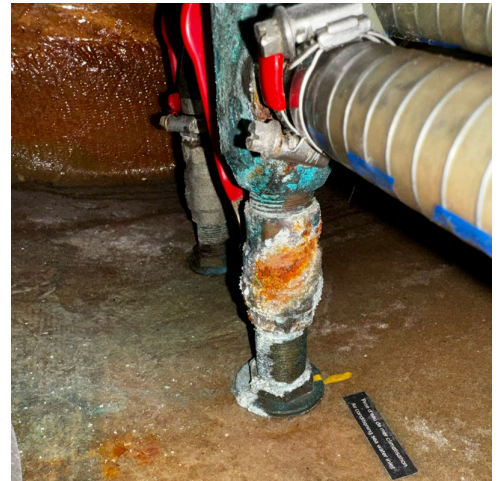
#5 **Location:** **Port hull / bilge compartment under aft cabin**

Observation: Heavy corrosion on sea valves

Result: ■ Serious flaw

Advice: Needs to be replaced

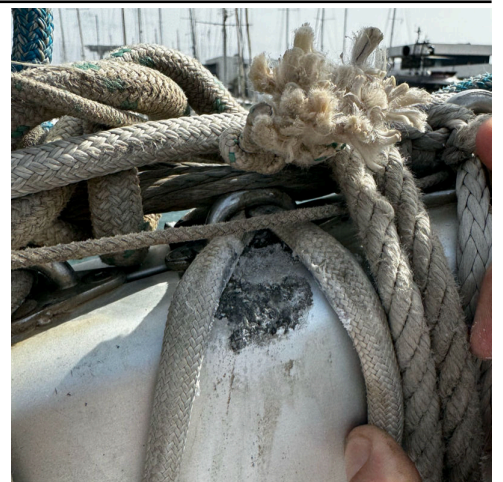
#6 **Location:** **Boom**

Observation: Heavy corrosion aft side of the boom

Result: ■ Flaw

Advice: Working and stable, but price reduction recommended

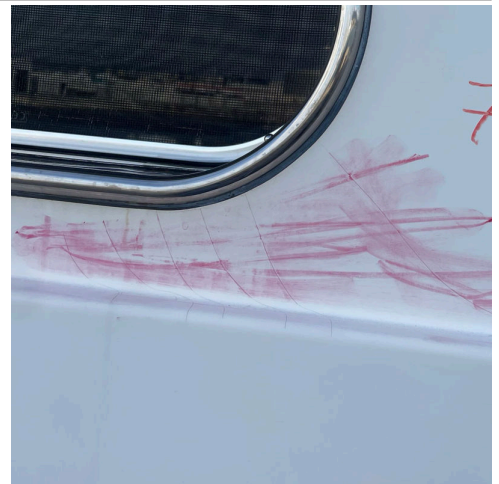
#7 **Location:** **Starboard hull**

Observation: Hairline cracking around porthole

Result: Flaw

Advice: Seal and polish

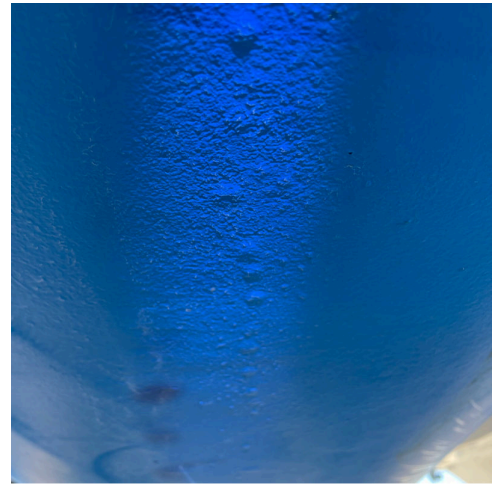
#8 **Location:** **Starboard hull**

Observation: Osmotic blisters along the hull joints of starboard hull

Result: Serious flaw

Advice: Needs a detail inspection and measurement of the humidity in hull. Serious flaw

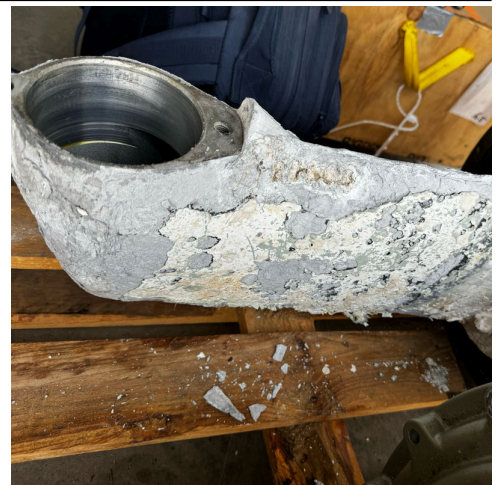
#9 **Location:** **Starboard Saildrive**

Observation: Heavy galvanic corrosion

Result: Serious flaw

Advice: Replace saildrive completely

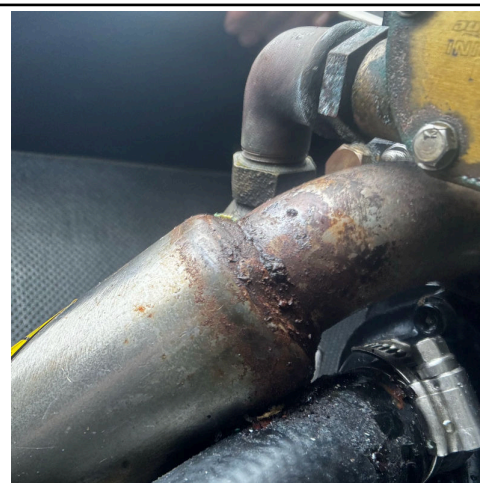
ID	Details	
#10	Location:	Starboard front locker
	Observation:	Leaking exhaust knee generator
	Advice:	Warranty: Replace completely under warranty
	Result:	 Serious flaw
	Date:	29/12/2024 04:12 PM
