Underwater Hull Inspection (final)

Type	Motorboat/Motoryacht
Name	Seven Seas
Model	Leader 46
Year of construction	2016
Boat type	Motoryacht
Hull no.	L4748567-84
WIN	HR4748585
Engine	2x Volvo Penta D4-50A
Flag	Croatia
Callsign	HR4858
MMSI	HR4959696

Date: February 19, 2025

Location: Marina Kornati

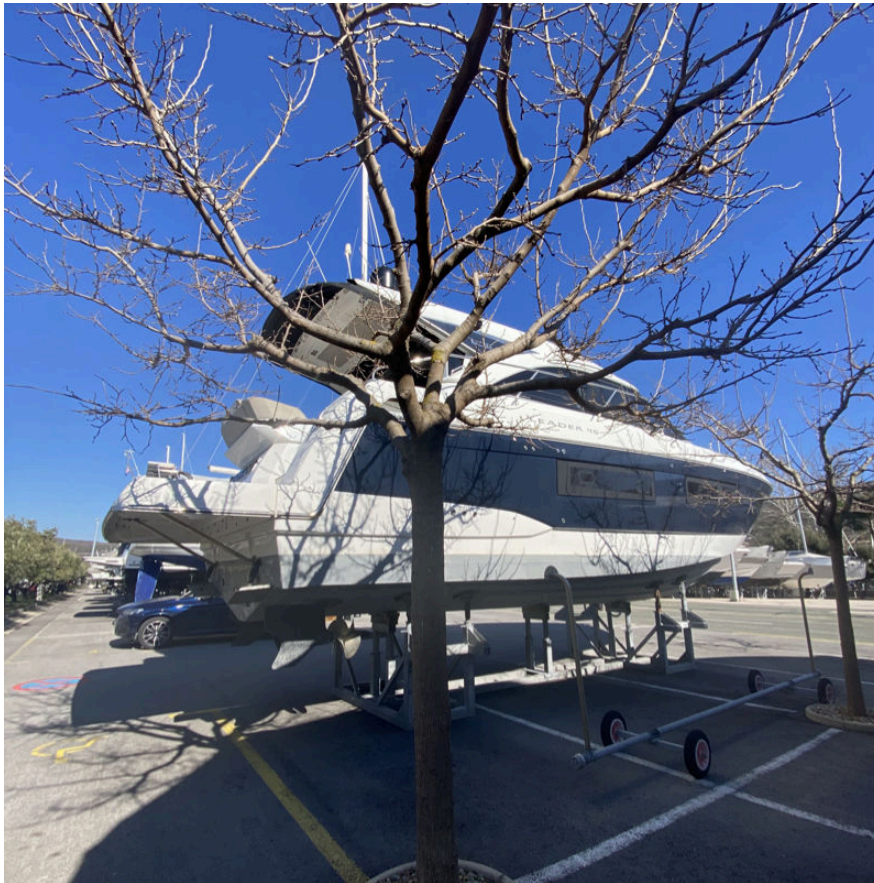
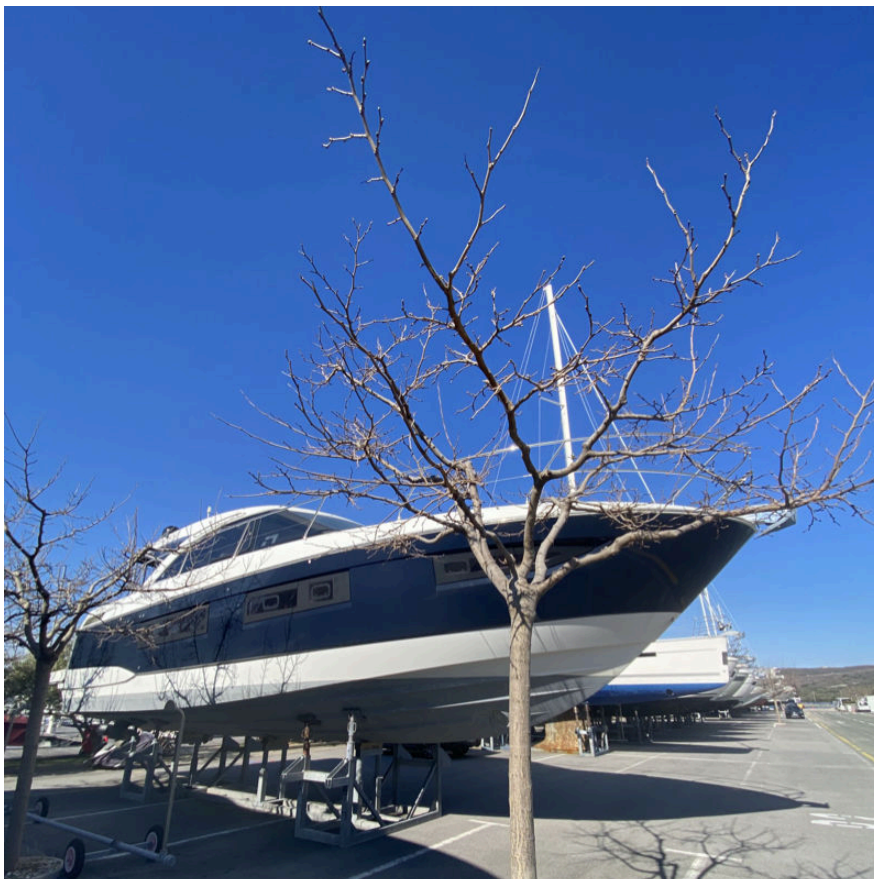
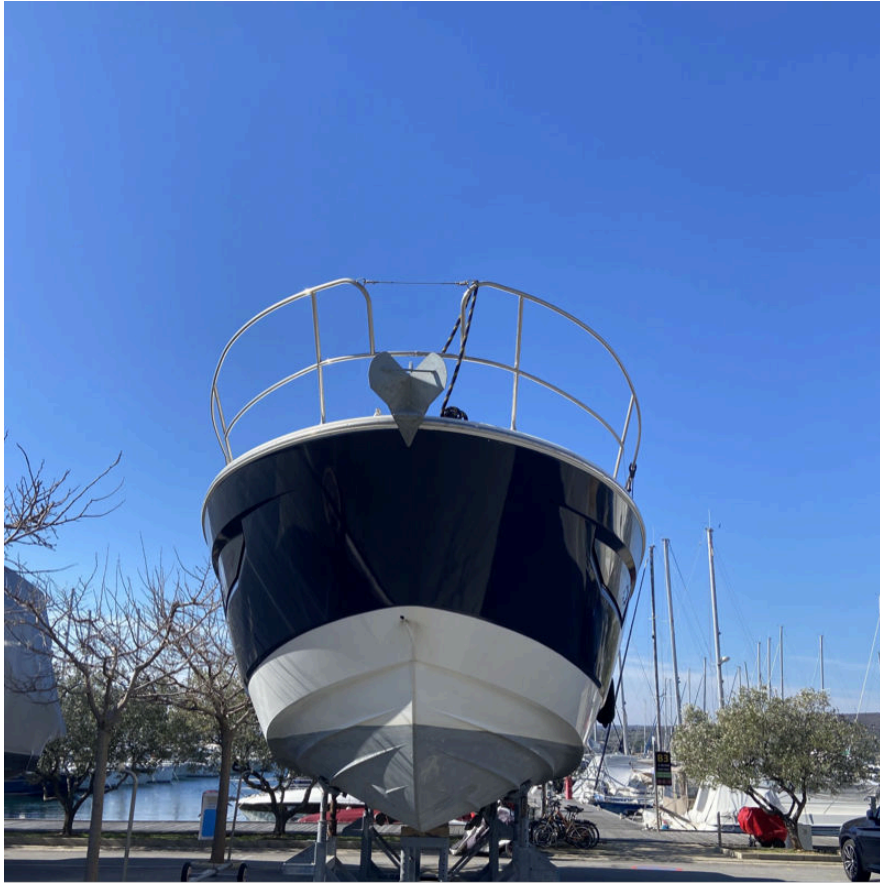
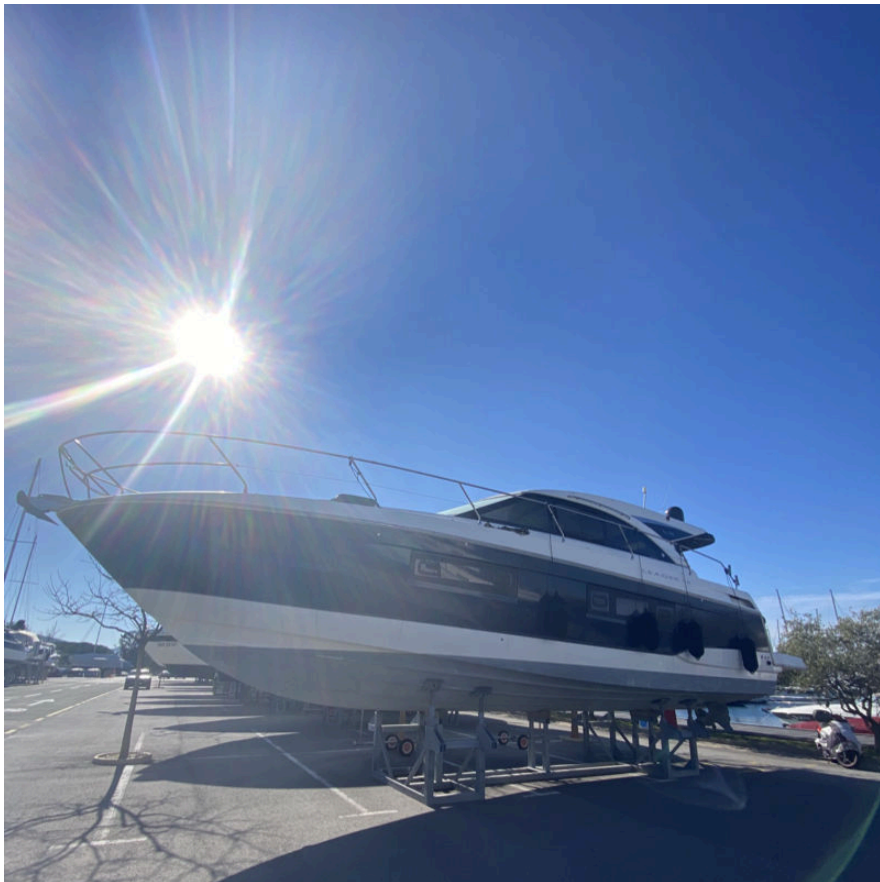
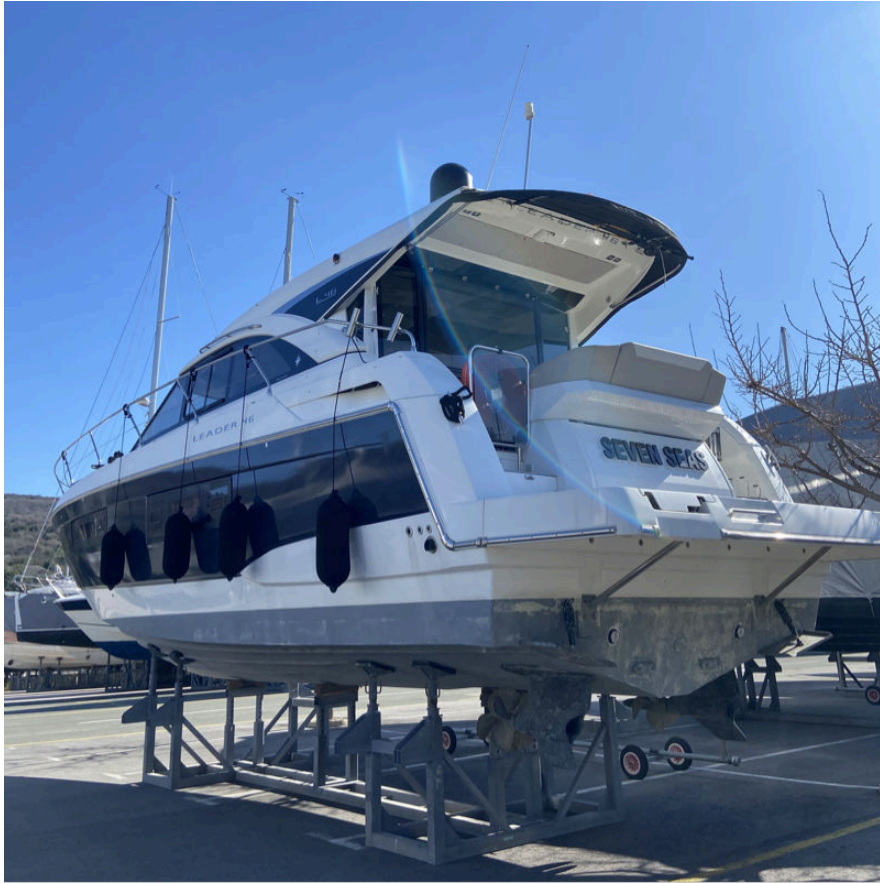
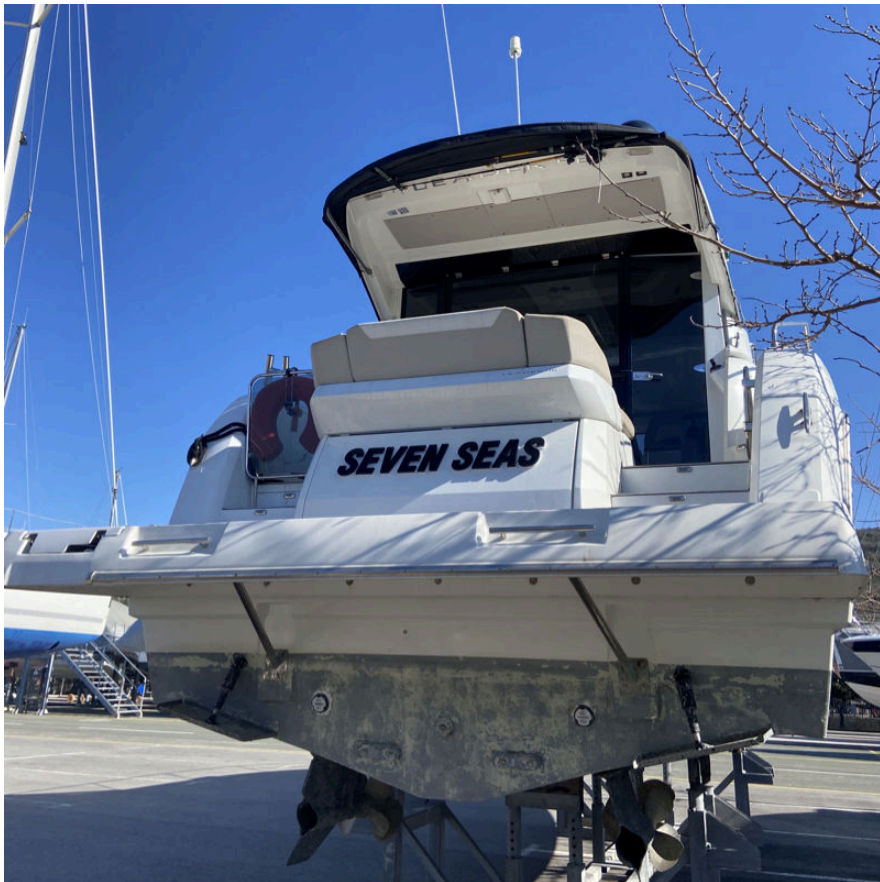
On February 19, 2025, an underwater hull inspection was conducted on the Leader 46 motor yacht Seven Seas while it was on land at Marina Kornati. The general condition of the hull was found to be satisfactory, with no structural issues detected. However, the antifouling coating was no longer present and requires reapplication.

Both propulsion drives were inspected and found to be in good condition. The propeller units appeared in reasonable shape, with no visible damage or significant wear. However, all sacrificial anodes must be replaced to ensure continued corrosion protection.
